HUMAN RESPONSES TO CHANGING COASTAL SYSTEMS

Infrastructure Construction

Roads and Bridges

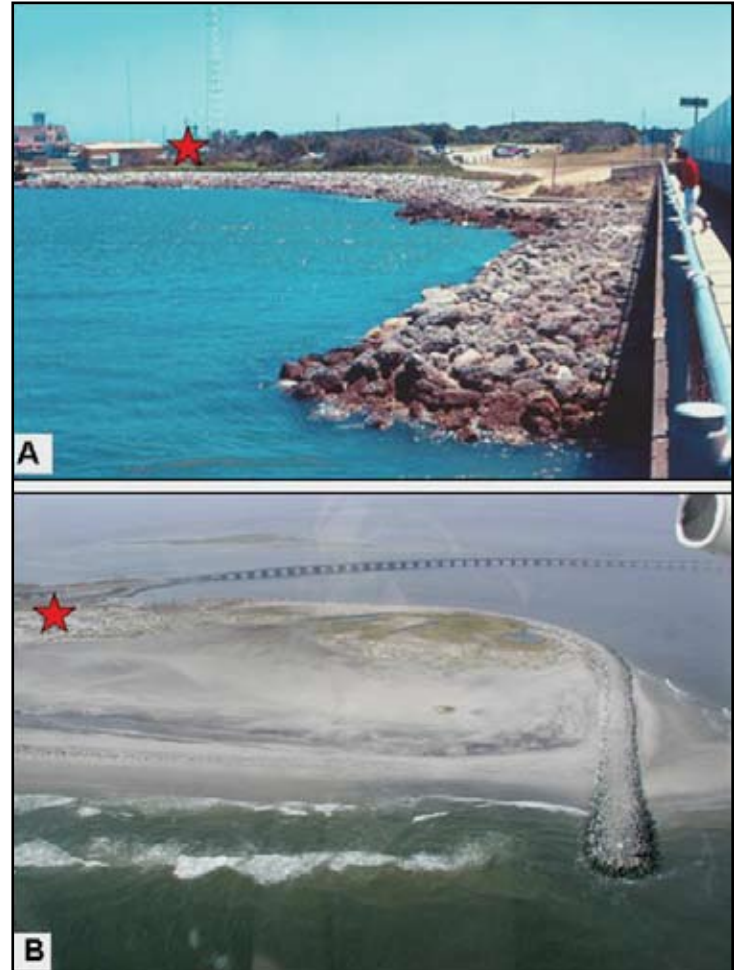
FIGURE 14. Photographs of the Oregon Inlet bridge with a rock revetment built in 1989 around the south end of the bridge to secure it to Pea Island (Panel A) and a jetty built in 1989-91 to stabilize the south shore of the migrating inlet (Panel B). The red star shows the location of the former U.S. Coast Guard Station. Photographs are by S. Riggs.

When the inlet approached the old U.S. Coast Guard Station, a variance was received from the NCCRC to stop inlet migration by constructing a rock jetty and to build an extensive rock revetment around the northern end of Pea Island to secure it to the bridge (Fig. 14). The jetty and revetment were built in 1989-1991 and did stop the southward migration of the inlet. In the meantime,

however, the northern side of the inlet continued to migrate southward, thus narrowing the inlet width and substantially deepening the navigational channel under the fixed bridge span. This, in turn, jeopardized the central bridge piles and rock fill was required to rebury the piles.
